**Flood Control Project Maintenance
Levee Inspections****LMA District Cover Sheet****Spring 2011 Levee Inspection Results****San Joaquin County Flood Control and Water Conservation District**

Spring 2011 Levee Inspection Results

San Joaquin County Flood Control and Water Conservation District

Waterway			Bank	Unit Miles
Unit No. 01 Littlejohn Creek			Left	2.87

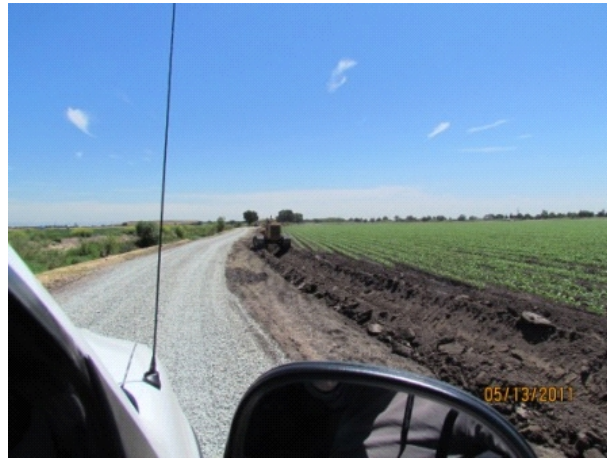
pkazi_s_20110517_552.jpg

The farmer made a ditch along the landside toe of the levee. The picture was taken from the crown looking upstream.

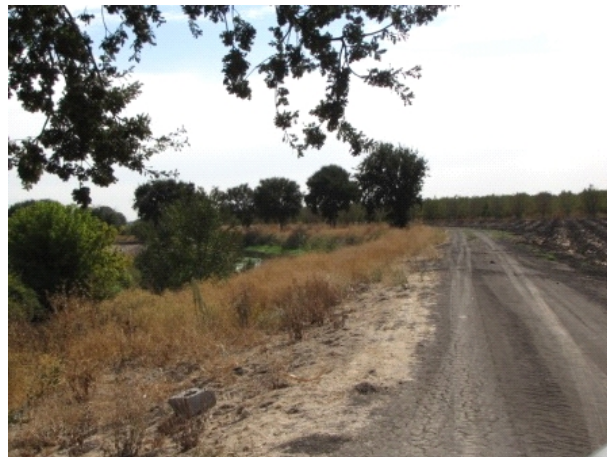
Levee Mile Report Line	2
Start Levee Mile	0.01
End Levee Mile	0.93
Location	Water Side
Category	Earthen Levee
Item	Vegetation

View of vegetation on the waterward side of the levee blocking visibility looking upstream.

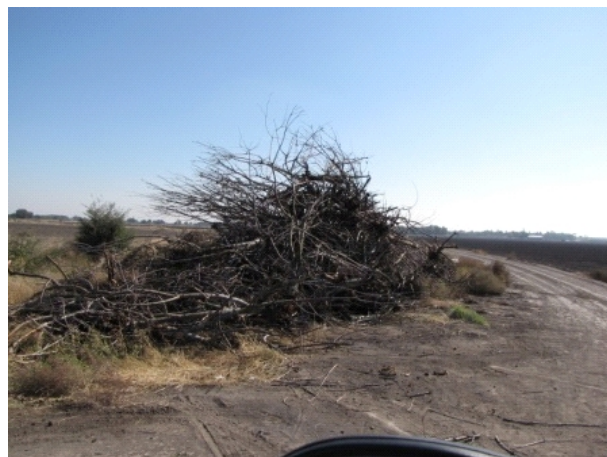
Levee Mile Report Line	4
Start Levee Mile	0.42
End Levee Mile	0.42
Location	Water Side
Category	Earthen Levee
Item	Encroachments

View of a prunings pile on the waterward side of the levee looking upstream.

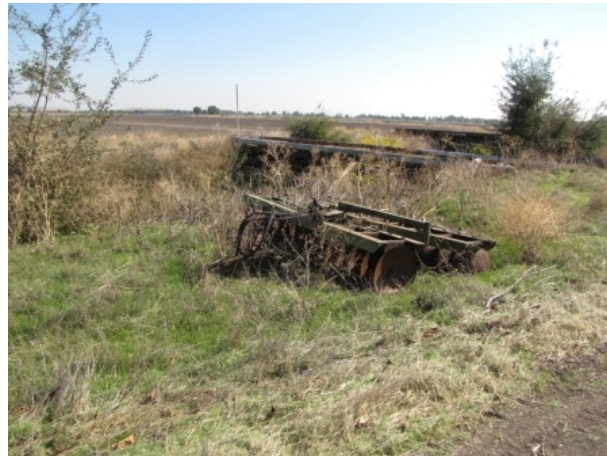
Levee Mile Report Line	5
Start Levee Mile	0.45
End Levee Mile	0.45
Location	Water Side
Category	Earthen Levee
Item	Encroachments
View of equipment on the waterward side of the levee looking upstream.	
pkazi_s_20110328_006.jpg

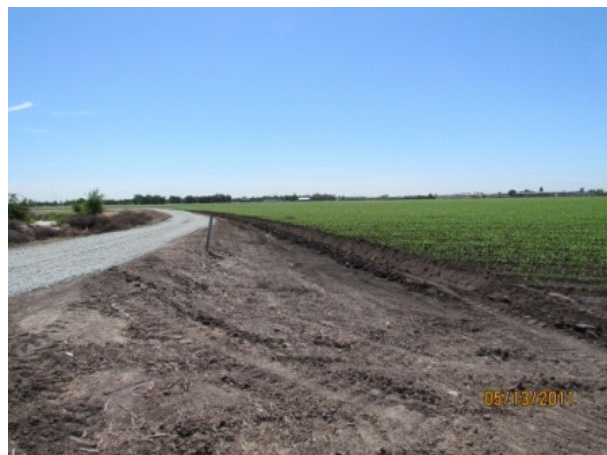
Levee Mile Report Line	6
Start Levee Mile	0.81
End Levee Mile	0.98
Location	Land Side
Category	Earthen Levee
Item	Encroachments
The farmer was discing the landward slope of the levee. The picture was taken from the landward toe of the levee looking upstream.	
pkazi_s_20110517_553.jpg

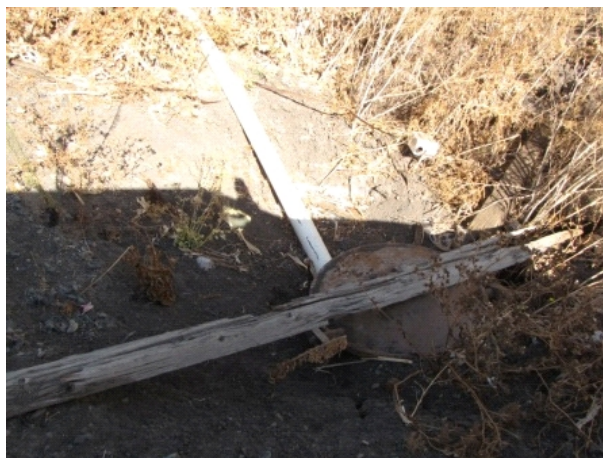
pkazi_s_20110328_010.jpg

View of a flap gate propped open with a pipe passing through on the waterward side of the levee.

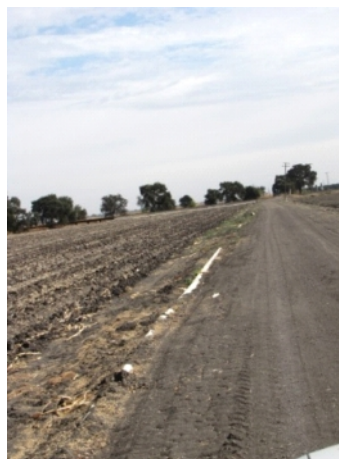
Levee Mile Report Line	12
Start Levee Mile	1.07
End Levee Mile	1.27
Location	Water Side
Category	Earthen Levee
Item	Encroachments

View of a pipe placed in the waterward slope of the levee looking upstream.

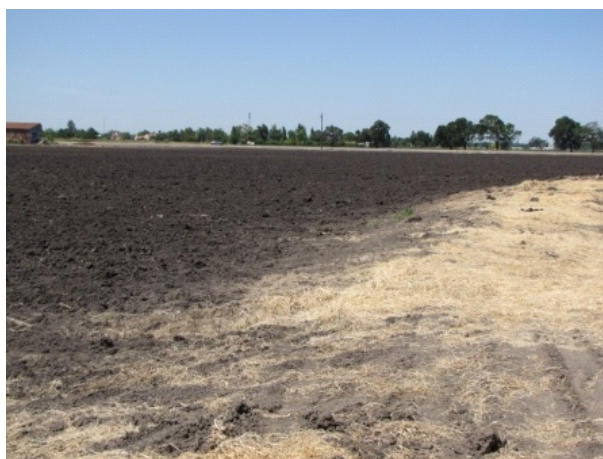
Levee Mile Report Line	13
Start Levee Mile	1.30
End Levee Mile	1.54
Location	Land Side
Category	Earthen Levee
Item	Encroachments

View of damage to the landward slope of the levee caused by the landowner driving a tractor over the levee looking downstream.

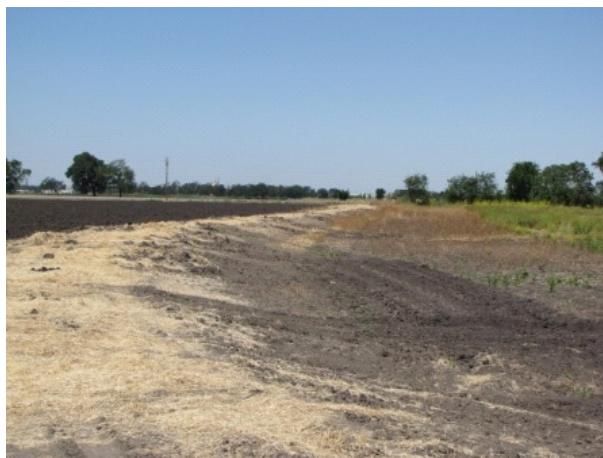
pkazi_s_20110328_013.jpg

View of damage to the waterward slope of the levee caused by the landowner driving a tractor over the levee looking downstream.

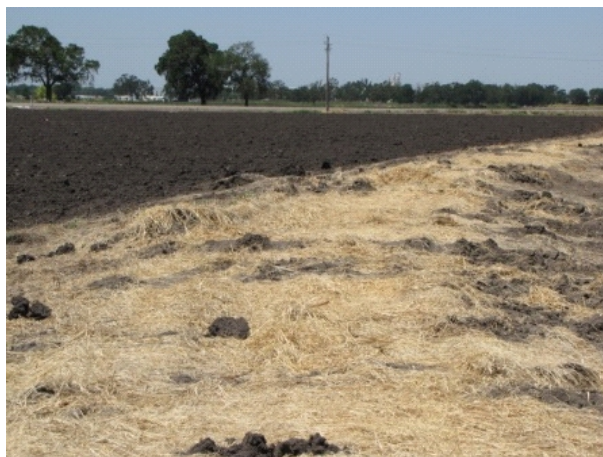
Levee Mile Report Line	15
Start Levee Mile	1.31
End Levee Mile	1.54
Location	Crown
Category	Earthen Levee
Item	Encroachments

View of damage to the crown of the levee caused by the landowner driving a tractor over the levee looking downstream.

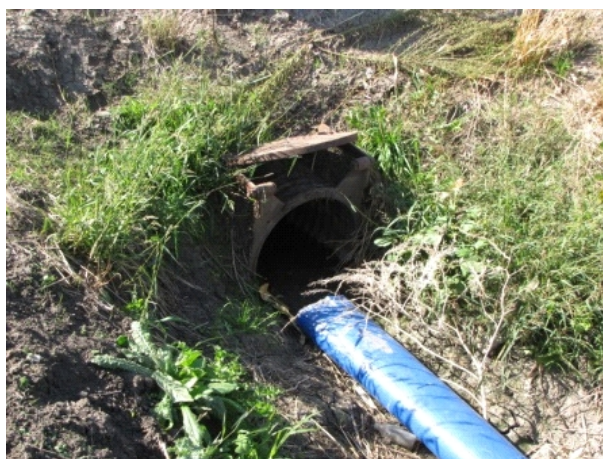
Levee Mile Report Line	16
Start Levee Mile	1.44
End Levee Mile	1.44
Location	Water Side
Category	Interior Drainage & Piping Systems
Item	Flap Gates

View of a blocked flap gate on the waterward side of the levee. Debris and sediment prevent this gate from closing.

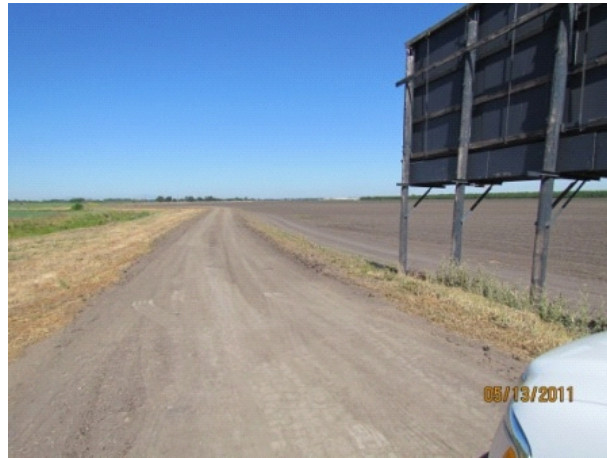
pkazi_s_20110517_548.jpg

The unwanted vegetation was removed from both land and waterside of the levee. The picture was taken from the crown looking downstream.

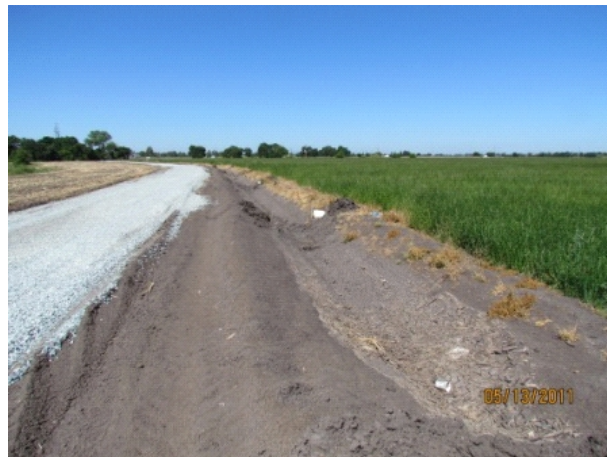
Levee Mile Report Line	4
Start Levee Mile	1.49
End Levee Mile	1.86
Location	Land Side
Category	Earthen Levee
Item	Encroachments

An agricultural ditch was discovered on the landside of the levee. The picture was taken from the crown of the levee looking downstream.

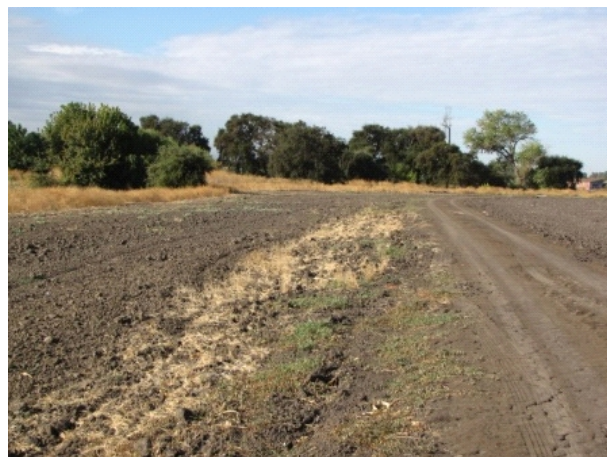
Levee Mile Report Line	5
Start Levee Mile	1.56
End Levee Mile	1.73
Location	Water Side
Category	Earthen Levee
Item	Encroachments

View of landowner's tilling on the waterward side and slope of the levee looking downstream.

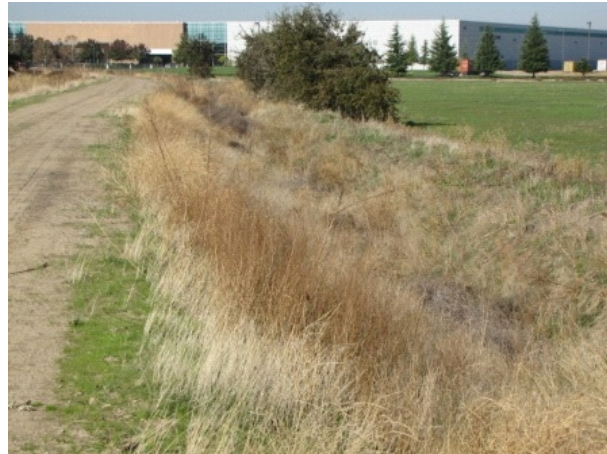
pkazi_s_20110328_022.jpg

View of an agricultural ditch on the landward side of the levee looking downstream.

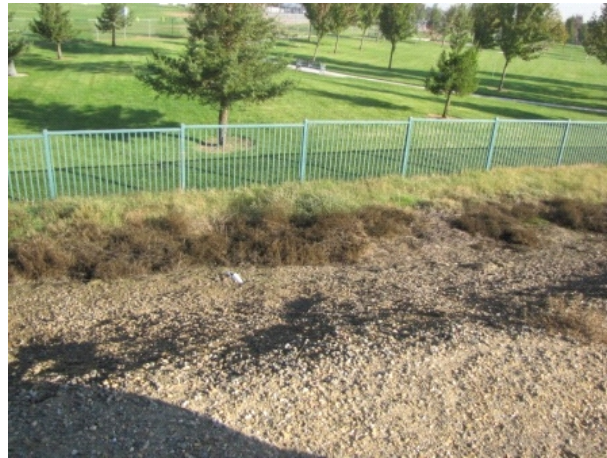
pkazi_s_20110328_024.jpg

View of the end of a 4" PVC pipe in the landward slope of the levee looking landward and upstream.

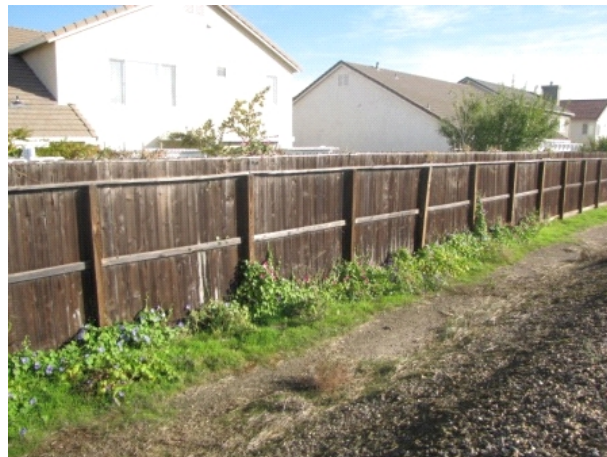
Levee Mile Report Line	5
Start Levee Mile	1.30
End Levee Mile	1.30
Location	Land Side
Category	Earthen Levee
Item	Encroachments

View of landscaping blocking visibility within 10' of the landward toe of the levee looking upstream.

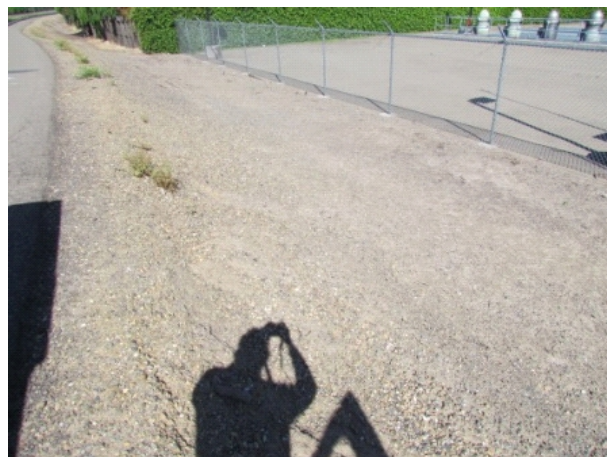
Levee Mile Report Line	7
Start Levee Mile	1.49
End Levee Mile	1.49
Location	Land Side
Category	Earthen Levee
Item	Encroachments

The stairways from the landside of the levee has been removed. The picture was taken from the crown of the levee looking downstream.

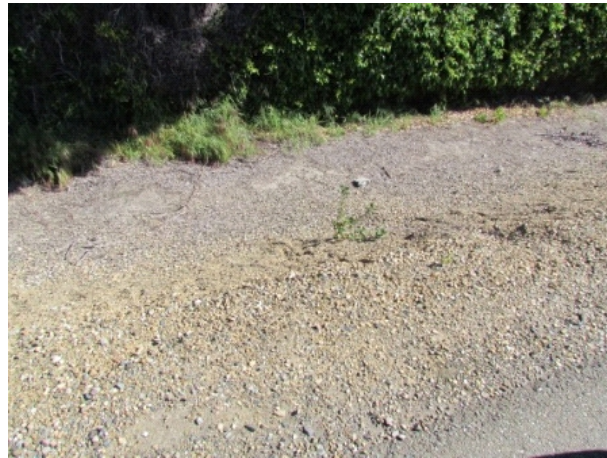
pkazi_s_20110502_520.jpg

The stairway was removed and the site was graded with new material. The picture was taken from the crown looking towards the landside toe of the levee facing upstream.

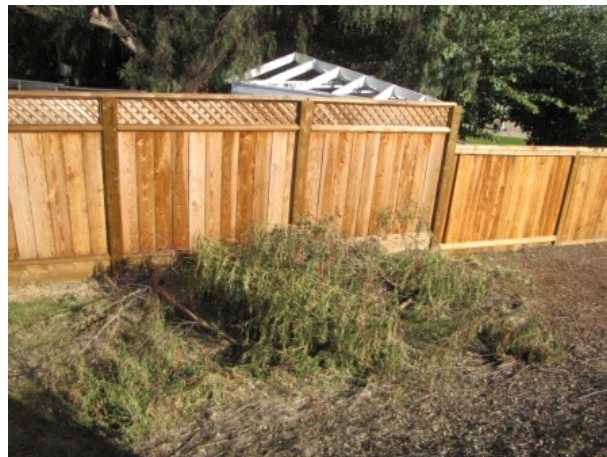
Levee Mile Report Line	11
Start Levee Mile	1.73
End Levee Mile	1.73
Location	Land Side
Category	Earthen Levee
Item	Encroachments

View of tree limbs at the landward toe looking landward and upstream.

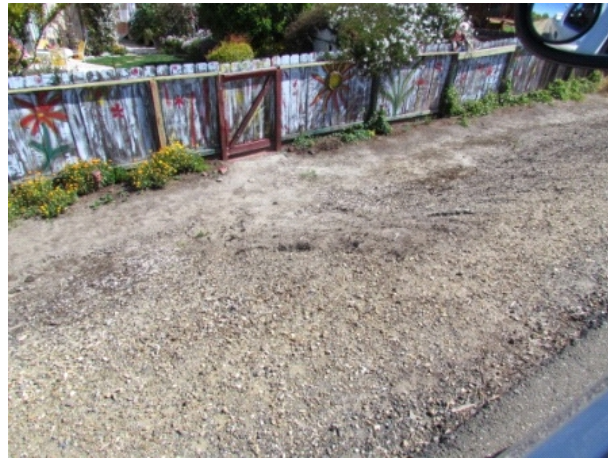
pkazi_s_20110502_522.jpg

The stairways were removed from the landside of the levee. The picture was taken from the crown looking upstream.

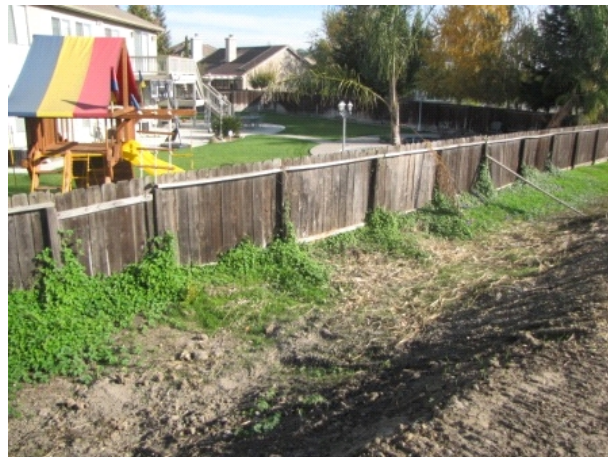
Levee Mile Report Line	15
Start Levee Mile	2.30
End Levee Mile	2.30
Location	Land Side
Category	Earthen Levee
Item	Encroachments

View of landscaping coming through the fence and blocking visibility within 10' of the landward toe looking upstream.

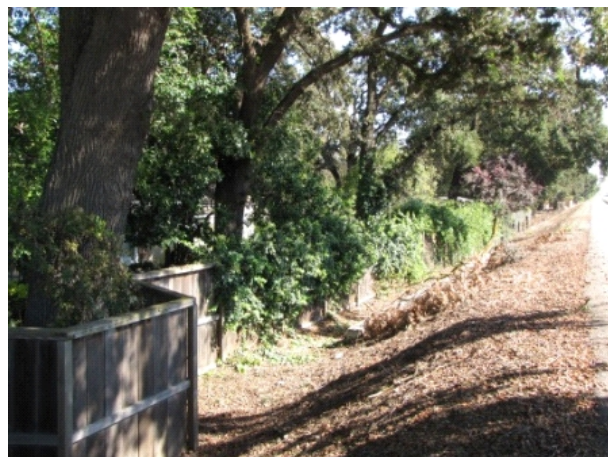
Levee Mile Report Line	17
Start Levee Mile	2.57
End Levee Mile	2.65
Location	Land Side
Category	Earthen Levee
Item	Encroachments

View of a wood fence adjacent to the landward toe looking upstream.

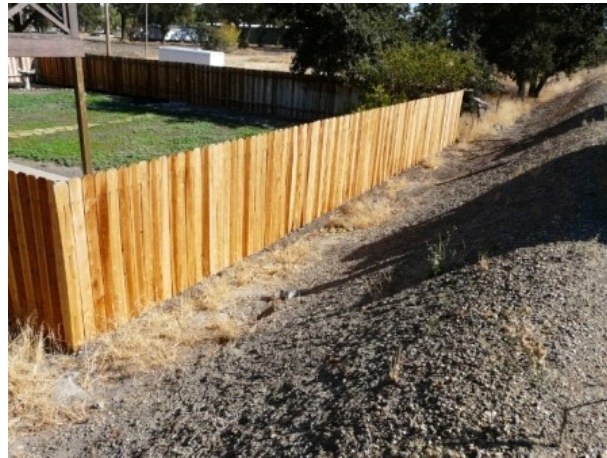
pkazi_s_20110328_032.JPG

Newer fence built within landside toe of levee at from LM 2.66 to LM 2.67.

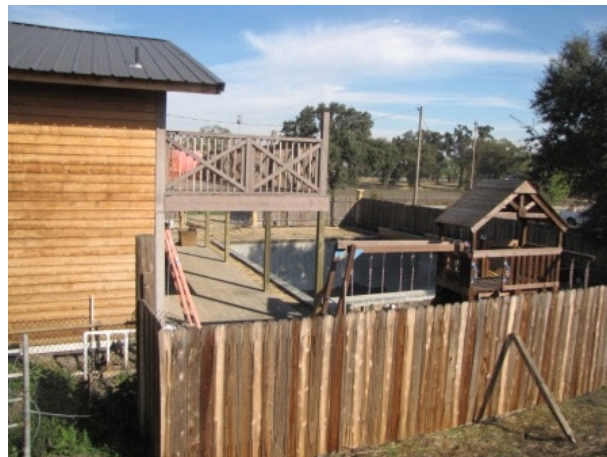
Levee Mile Report Line	19
Start Levee Mile	2.67
End Levee Mile	2.67
Location	Land Side
Category	Earthen Levee
Item	Encroachments

View of a recently constructed pool looking landward.

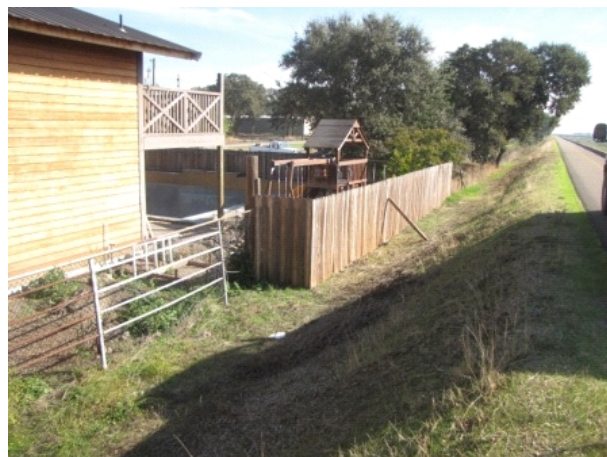
Levee Mile Report Line	19
Start Levee Mile	2.67
End Levee Mile	2.67
Location	Land Side
Category	Earthen Levee
Item	Encroachments

View of a recently constructed pool looking upstream.

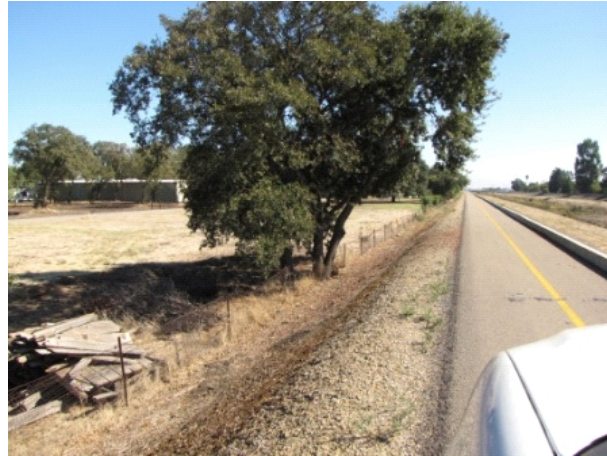
Levee Mile Report Line	20
Start Levee Mile	2.68
End Levee Mile	3.04
Location	Land Side
Category	Earthen Levee
Item	Encroachments
View of a metal fence adjacent to the landward toe looking upstream.	
pkazi_s_20110328_058.jpg

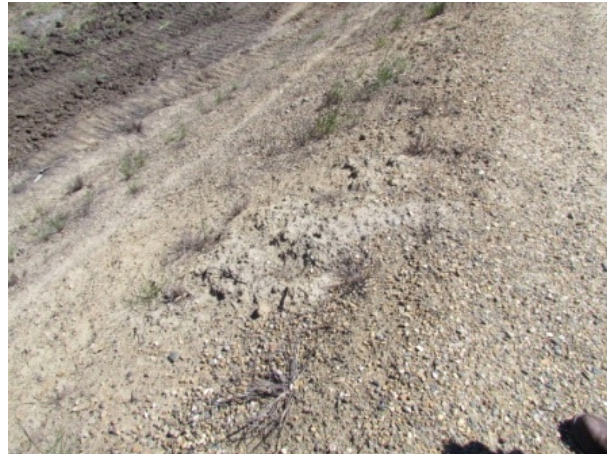
Levee Mile Report Line	23
Start Levee Mile	3.92
End Levee Mile	3.92
Location	Land Side
Category	Earthen Levee
Item	Animal Control
Rodent holes were filled with grout. The picture was taken from the crown of the levee looking upstream.	
pkazi_s_20110502_523.jpg

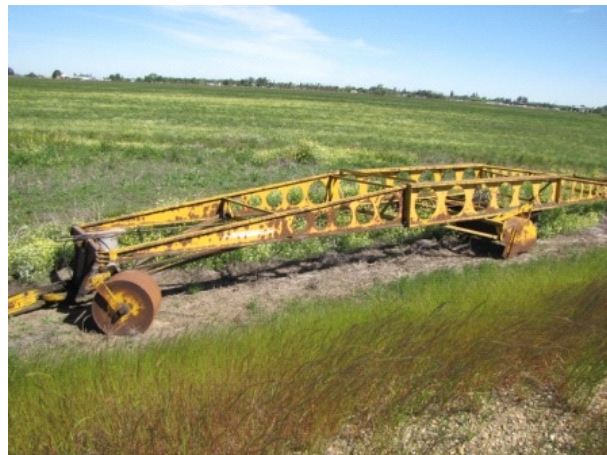
Levee Mile Report Line	26
Start Levee Mile	5.10
End Levee Mile	5.10
Location	Land Side
Category	Earthen Levee
Item	Encroachments
View of farming equipment parked at the toe of the levee.	
pkazi_s_20110328_030.jpg

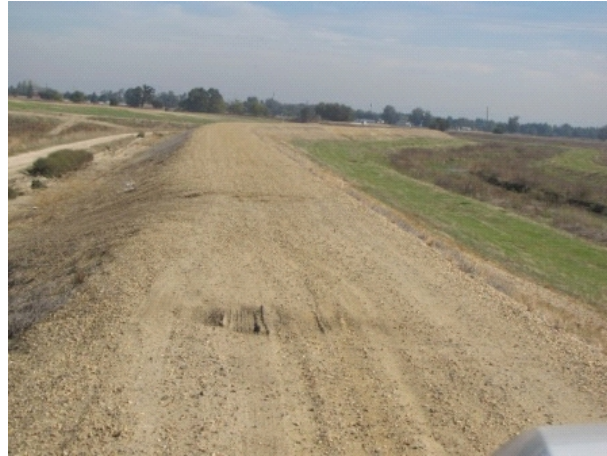
pkazi_s_20110328_046.jpg

View of a depression in the crown of the levee looking upstream.

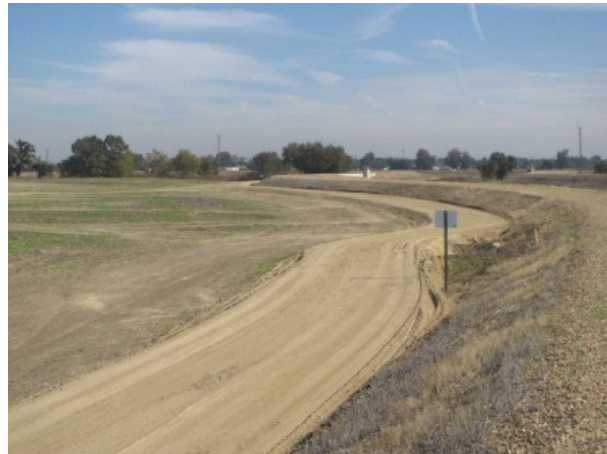
Levee Mile Report Line	31
Start Levee Mile	6.19
End Levee Mile	6.47
Location	Land Side
Category	Earthen Levee
Item	Encroachments

View of soil placed along the landward toe of the levee looking upstream.

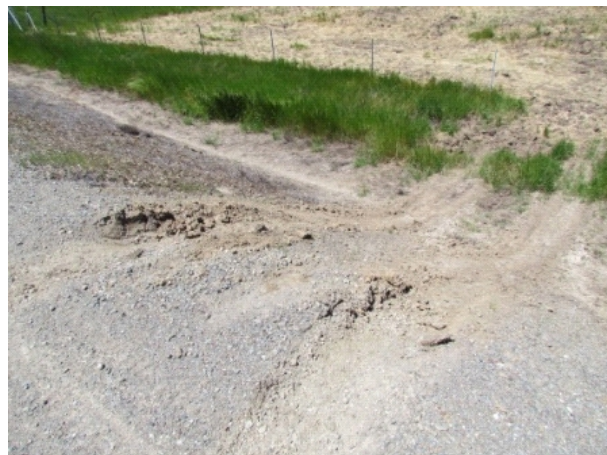
Levee Mile Report Line	33
Start Levee Mile	7.50
End Levee Mile	7.50
Location	Land Side
Category	Earthen Levee
Item	Slope Stability

Erosion caused by vehicular traffic at the shoulder of landward side of the levee. The picture was taken from the crown of the levee looking downstream.

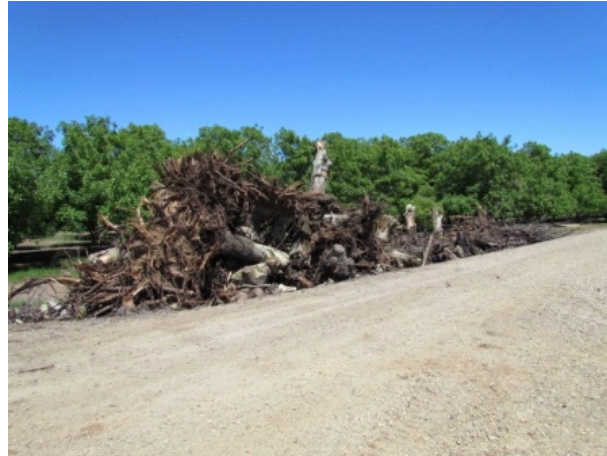
pkazi_s_20110508_525.jpg

Burn piles on the landside of the levee. The picture was taken from the crown of the levee looking upstream.

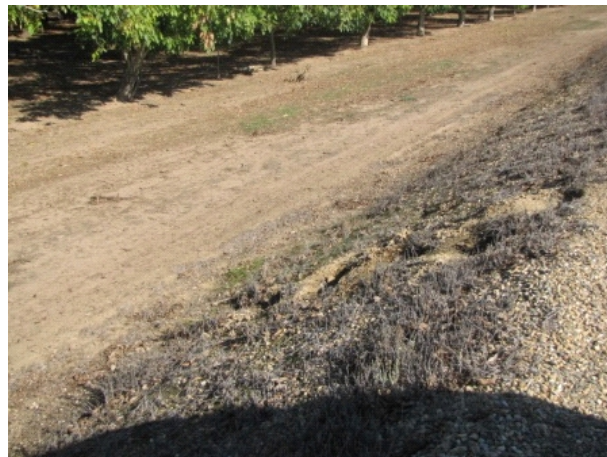
Levee Mile Report Line	41
Start Levee Mile	9.23
End Levee Mile	9.23
Location	Land Side
Category	Earthen Levee
Item	Encroachments

View of steps dug into the landward slope of the levee looking upstream.

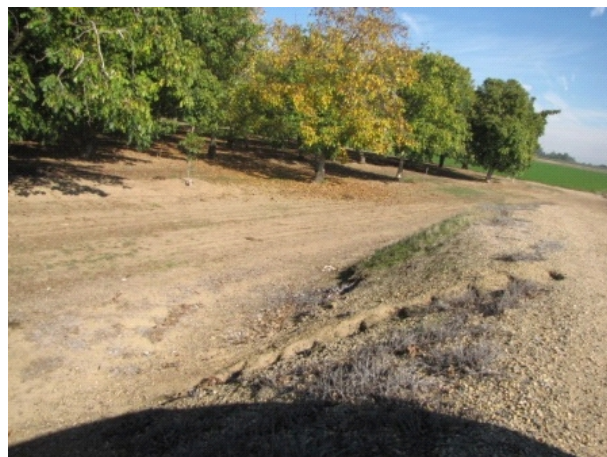
Levee Mile Report Line	42
Start Levee Mile	9.37
End Levee Mile	9.37
Location	Land Side
Category	Earthen Levee
Item	Encroachments

View of steps dug into the landward slope of the levee adjacent to a ramp looking upstream.

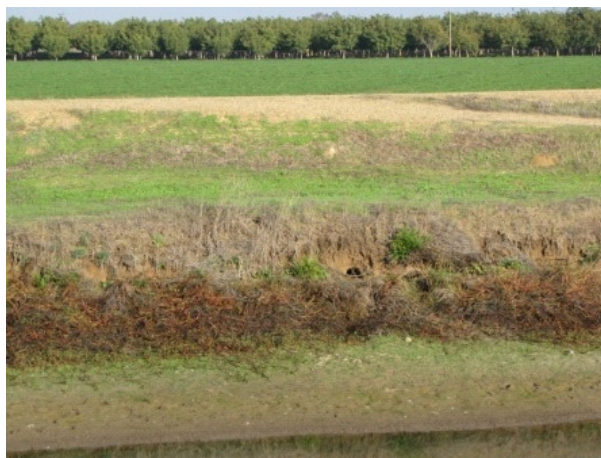
pkazi_s_20110328_053.jpg

View of a large hole in the waterward berm from across the channel.

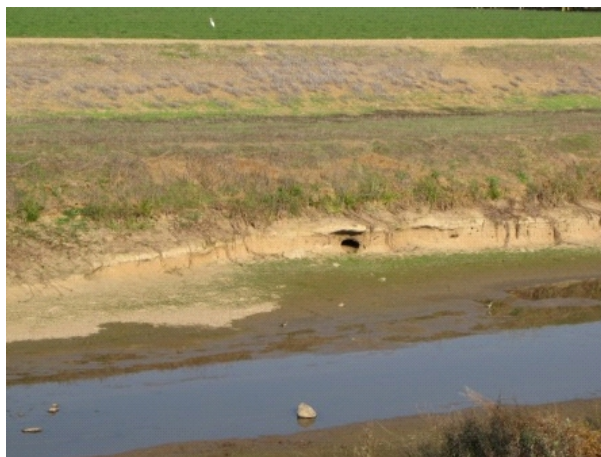
Levee Mile Report Line	44
Start Levee Mile	9.65
End Levee Mile	9.65
Location	Water Side
Category	Earthen Levee
Item	Animal Control

View of a large hole and several smaller holes from across the channel.

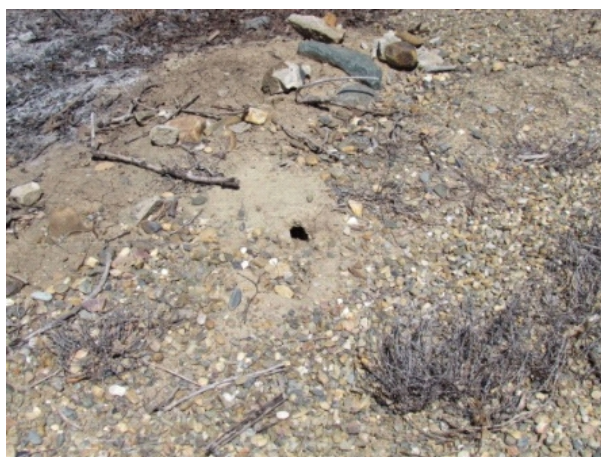
Levee Mile Report Line	46
Start Levee Mile	9.91
End Levee Mile	9.91
Location	Land Side
Category	Earthen Levee
Item	Animal Control

A rodent hole was located on the landside shoulder of the levee. The picture was taken from the crown of the levee looking upstream.

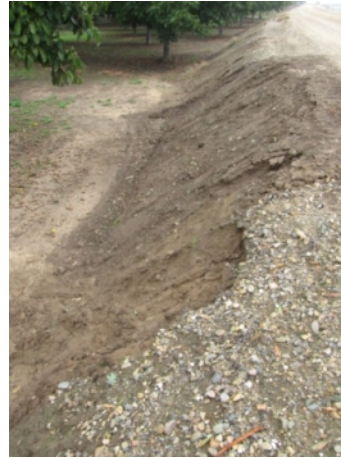
pkazi_s_20110328_061.jpg

View of erosion occurring on a recent slope repair on the landward slope looking upstream.

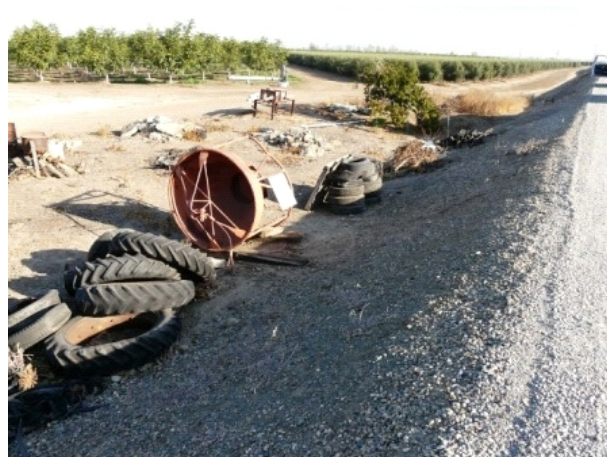
pkazi_s_20110328_026.JPG

Levee Mile Report Line	60
Start Levee Mile	10.95
End Levee Mile	10.96
Location	Land Side
Category	Earthen Levee
Item	Encroachments

Debris located along landside toe of levee from LM 10.95 to LM 10.96.

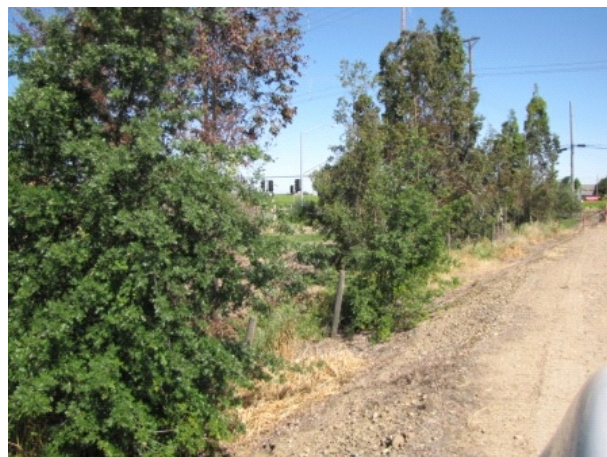
pkazi_s_20110328_041.jpg

View of trees blocking visibility along the landward toe looking upstream.

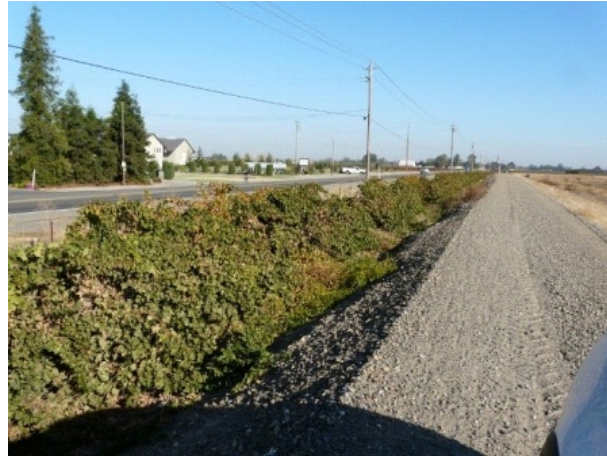
Levee Mile Report Line	68
Start Levee Mile	13.39
End Levee Mile	13.51
Location	Land Side
Category	Earthen Levee
Item	Encroachments
Grape vines within 10' from landside toe of levee from LM 13.39 to 13.51.	
pkazi_s_20110328_036.JPG

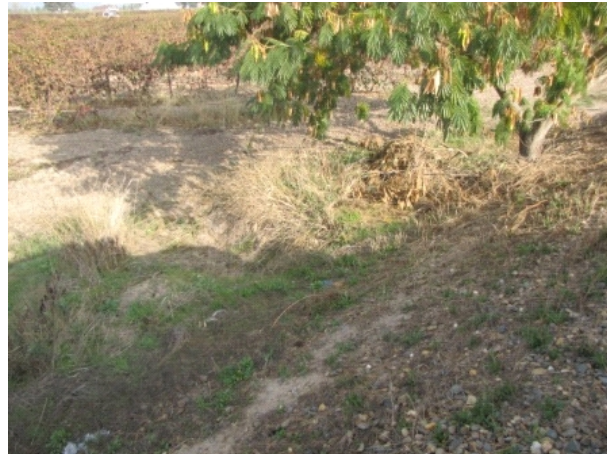
Levee Mile Report Line	69
Start Levee Mile	13.55
End Levee Mile	13.55
Location	Land Side
Category	Earthen Levee
Item	Slope Stability
View of a pit along the landward levee toe looking upstream.	
pkazi_s_20110328_050.jpg

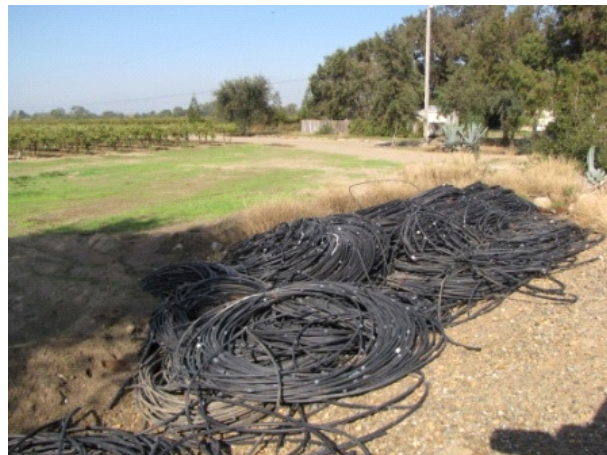
Levee Mile Report Line	73
Start Levee Mile	13.99
End Levee Mile	13.99
Location	Land Side
Category	Earthen Levee
Item	Encroachments
View of irrigation pipe on the landward slope.	
pkazi_s_20110328_065.jpg

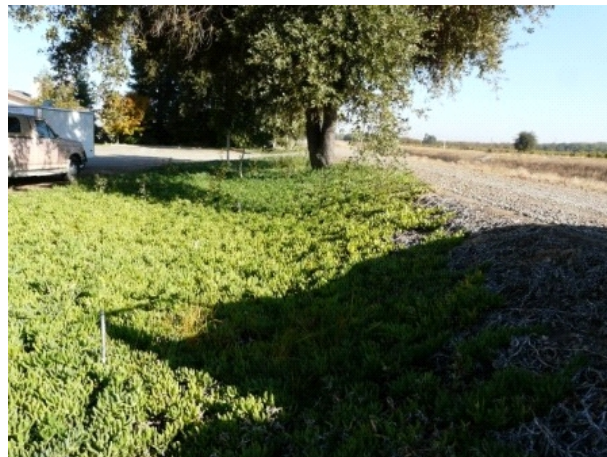
pkazi_s_20110328_038.JPG

Levee Mile Report Line	76
Start Levee Mile	14.09
End Levee Mile	14.13
Location	Land Side
Category	Earthen Levee
Item	Encroachments

Landscaping on landside of levee from LM 14.09 to LM 14.13.

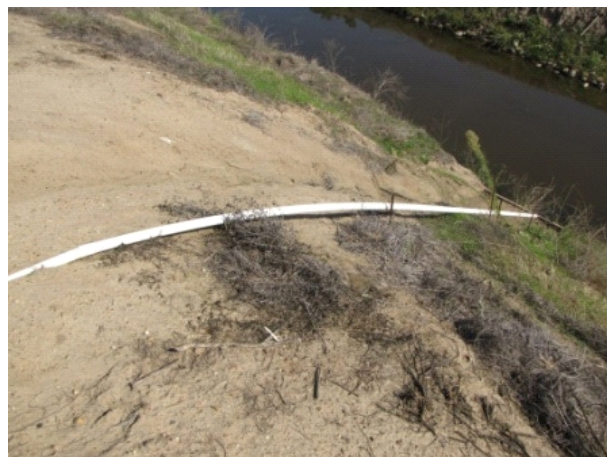
pkazi_s_20110328_066.jpg

Levee Mile Report Line	79
Start Levee Mile	14.77
End Levee Mile	14.77
Location	Water Side
Category	Earthen Levee
Item	Encroachments

View of a pipe a landowner placed in the access road and waterward slope to pump water from the channel to irrigate their garden.

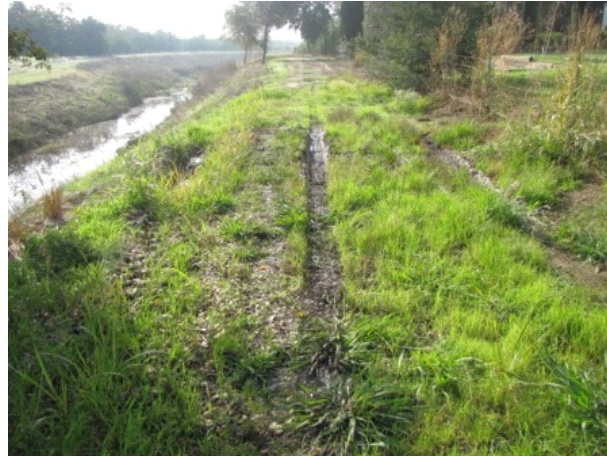
Levee Mile Report Line	80
Start Levee Mile	14.89
End Levee Mile	14.89
Location	Water Side
Category	Earthen Levee
Item	Crown Surface / Depressions / Rutting
View of a saturated portion of the access road with rutting, especially at the waterward hinge looking downstream.	
pkazi_s_20110328_051.jpg

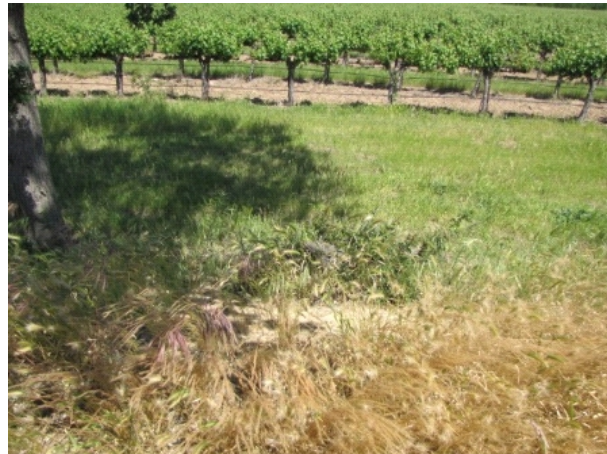
Levee Mile Report Line	84
Start Levee Mile	15.72
End Levee Mile	15.72
Location	Land Side
Category	Earthen Levee
Item	Trim / Thin Trees
View of a stump in the landward slope.	
pkazi_s_20110328_045.jpg

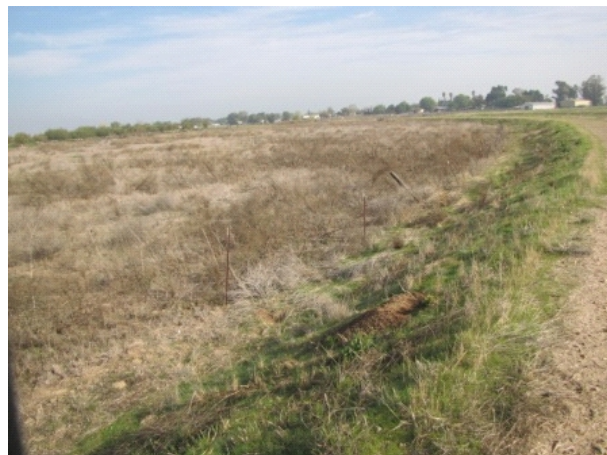
Levee Mile Report Line	85
Start Levee Mile	15.87
End Levee Mile	15.87
Location	Land Side
Category	Earthen Levee
Item	Animal Control
View of rodent activity along the landward slope looking upstream.	
pkazi_s_20110328_052.jpg

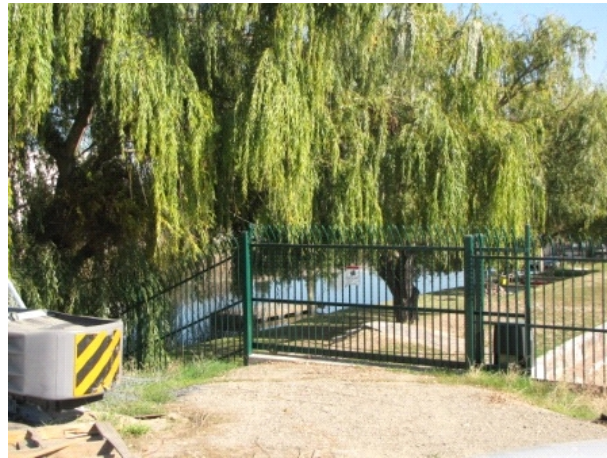
pkazi_s_20110328_107.jpg

View of a open fence and gate across the crown at the current start of the unit looking upstream. Limited access has been provided.

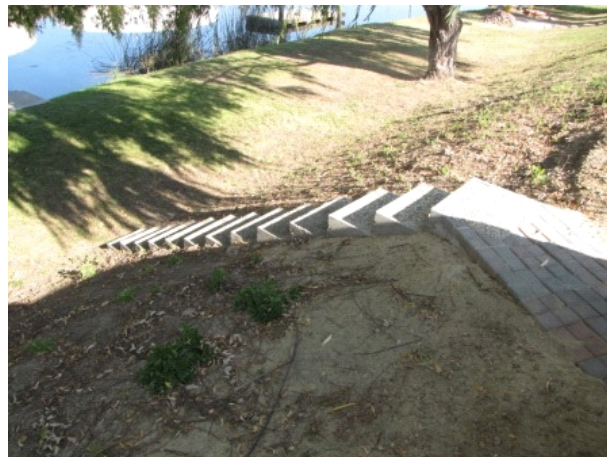
pkazi_s_20110328_108.jpg

Levee Mile Report Line	2
Start Levee Mile	0.78
End Levee Mile	0.78
Location	Water Side
Category	Earthen Levee
Item	Encroachments

View of steps on the waterward slope of the levee looking upstream.

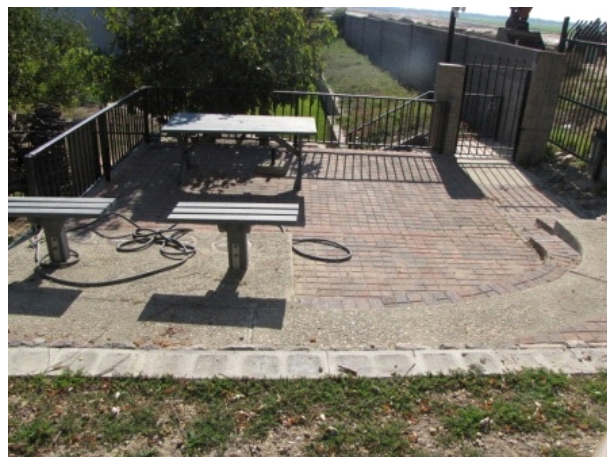
pkazi_s_20110328_109.jpg

Levee Mile Report Line	3
Start Levee Mile	0.78
End Levee Mile	0.79
Location	Land Side
Category	Earthen Levee
Item	Encroachments

View of a patio with table, benches, and irrigation on the landward side of the levee.

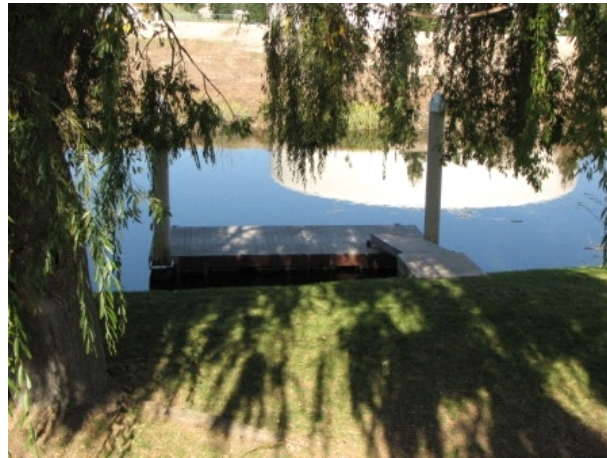
pkazi_s_20110328_110.jpg

View of a dock off the waterward berm.

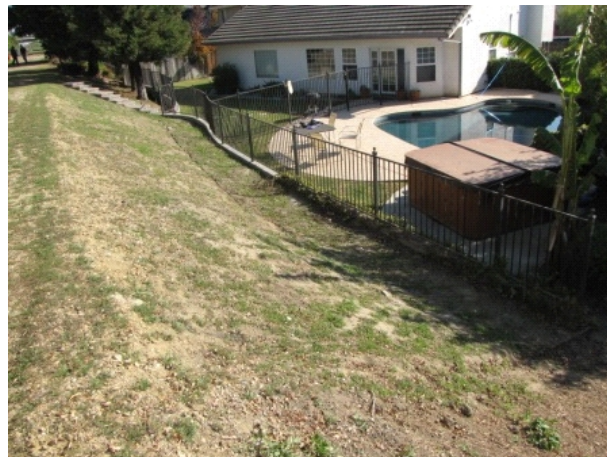
pkazi_s_20110328_111.jpg

Levee Mile Report Line	5
Start Levee Mile	0.79
End Levee Mile	0.81
Location	Land Side
Category	Earthen Levee
Item	Encroachments

View of a fence on top of a retaining wall in the landward toe of the levee. Some landscaping and irrigation are also present.

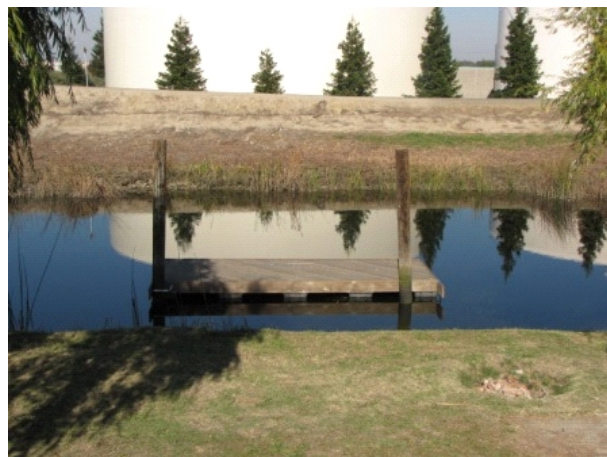
pkazi_s_20110328_112.jpg

Levee Mile Report Line	6
Start Levee Mile	0.80
End Levee Mile	0.80
Location	Water Side
Category	Earthen Levee
Item	Encroachments

View of a dock off the waterward side of the berm.

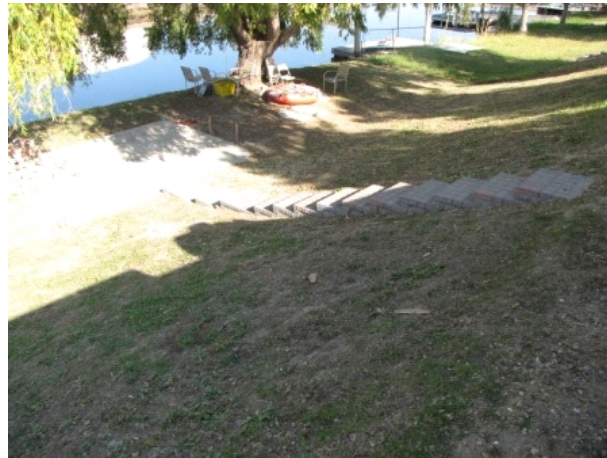
Levee Mile Report Line	7
Start Levee Mile	0.80
End Levee Mile	0.80
Location	Water Side
Category	Earthen Levee
Item	Encroachments
View of stairs and patio on the waterward slope and berm looking upstream.	
pkazi_s_20110328_113.jpg

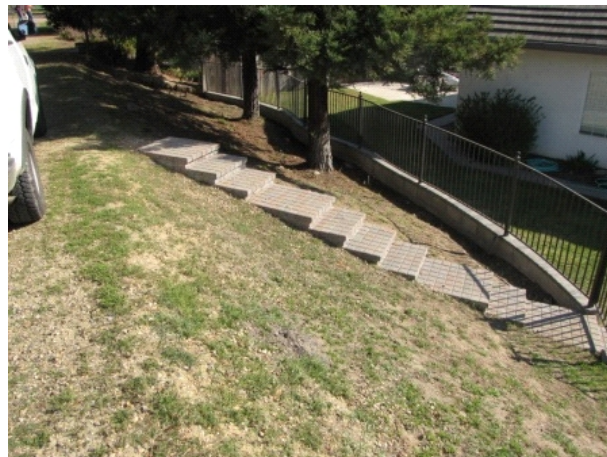
Levee Mile Report Line	8
Start Levee Mile	0.80
End Levee Mile	0.80
Location	Land Side
Category	Earthen Levee
Item	Encroachments
View of steps on the landward slope looking upstream.	
pkazi_s_20110328_122.jpg

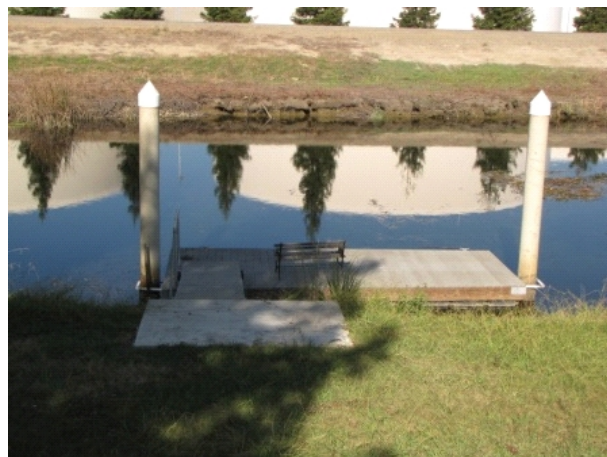
Levee Mile Report Line	9
Start Levee Mile	0.81
End Levee Mile	0.81
Location	Water Side
Category	Earthen Levee
Item	Encroachments
View of a dock on the waterward side of the berm.	
pkazi_s_20110328_118.jpg

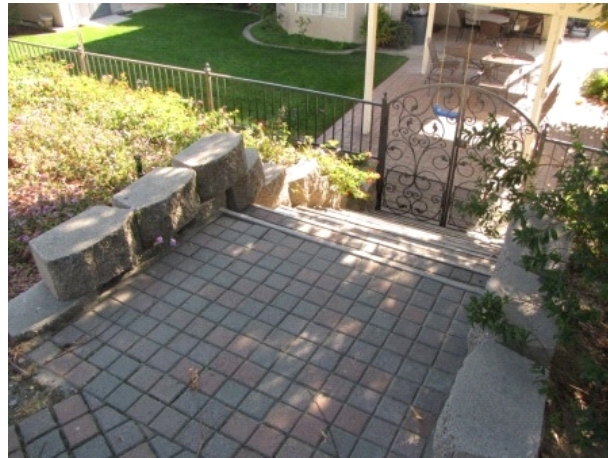
pkazi_s_20110328_116.jpg

View of steps on the landward slope.

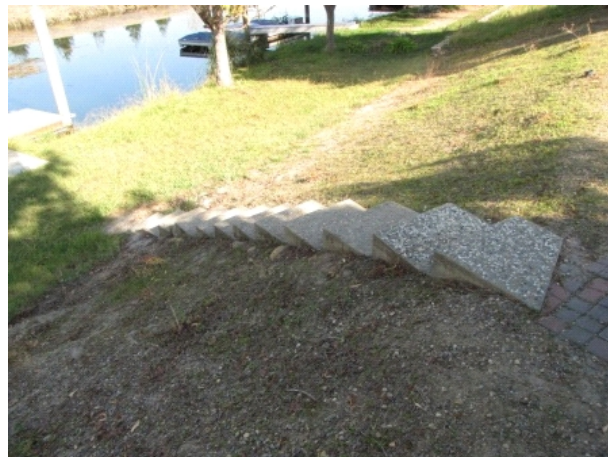
pkazi_s_20110328_117.jpg

Levee Mile Report Line	11
Start Levee Mile	0.81
End Levee Mile	0.81
Location	Water Side
Category	Earthen Levee
Item	Encroachments

View of steps on the waterward slope looking upstream.

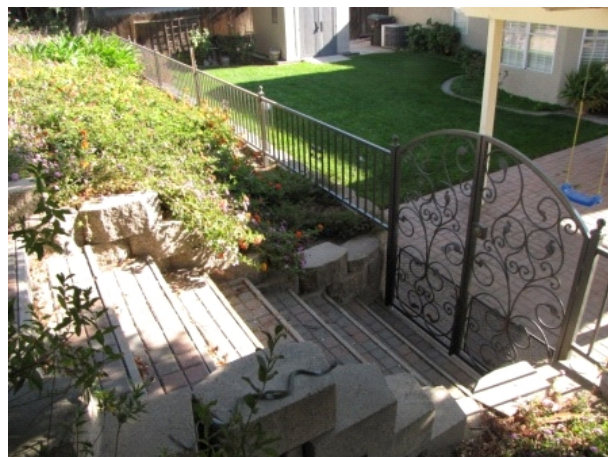
pkazi_s_20110328_114.jpg

Levee Mile Report Line	12
Start Levee Mile	0.81
End Levee Mile	0.82
Location	Land Side
Category	Earthen Levee
Item	Encroachments

View of a open fence on a retaining wall in the landward toe of the levee looking upstream.

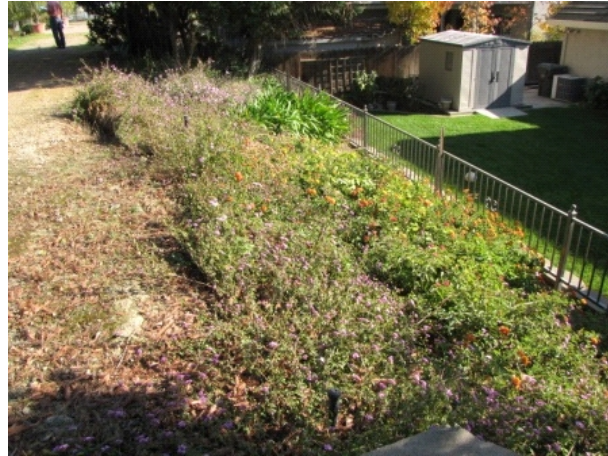
pkazi_s_20110328_115.jpg

View of landscaping obstructing visibility and access and irrigation along the landward slope looking upstream.

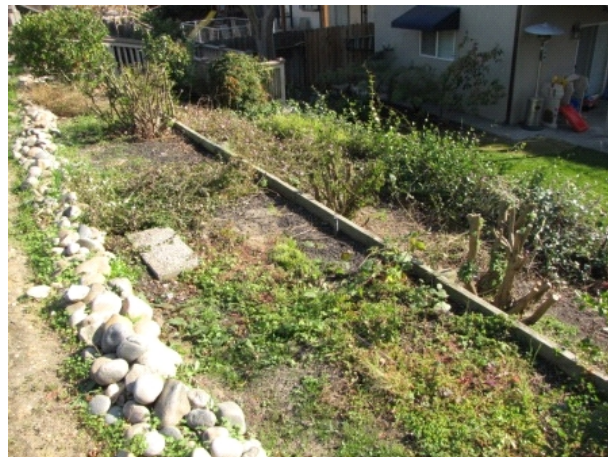
pkazi_s_20110328_119.jpg

Levee Mile Report Line	15
Start Levee Mile	0.82
End Levee Mile	0.83
Location	Land Side
Category	Earthen Levee
Item	Encroachments

View of landscaping and irrigation along the landward slope looking upstream.

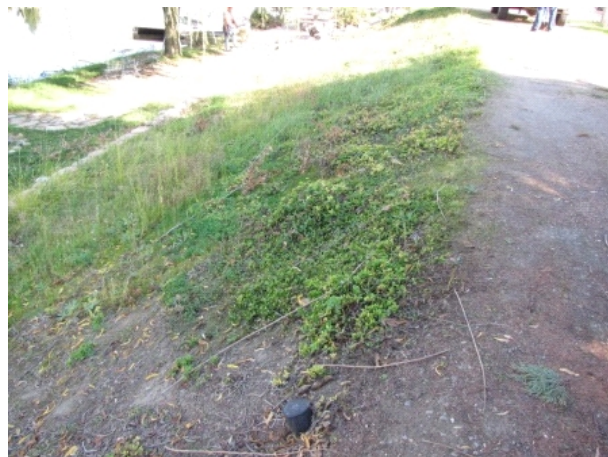
pkazi_s_20110328_120.jpg

Levee Mile Report Line	16
Start Levee Mile	0.82
End Levee Mile	0.83
Location	Water Side
Category	Earthen Levee
Item	Encroachments

View of landscaping and irrigation on the waterward slope looking upstream.

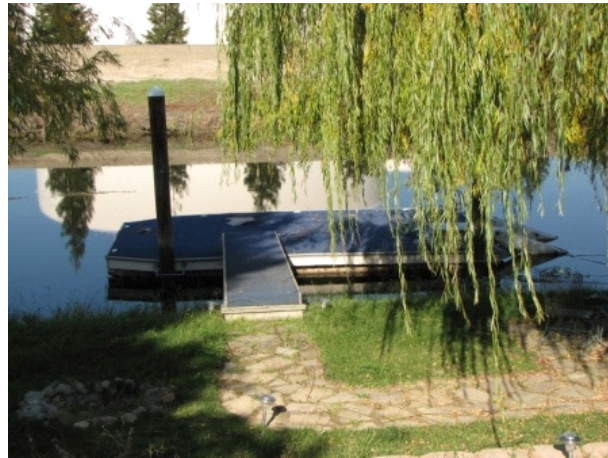
pkazi_s_20110328_121.jpg

View of a dock and pathway on the waterward side of the berm.

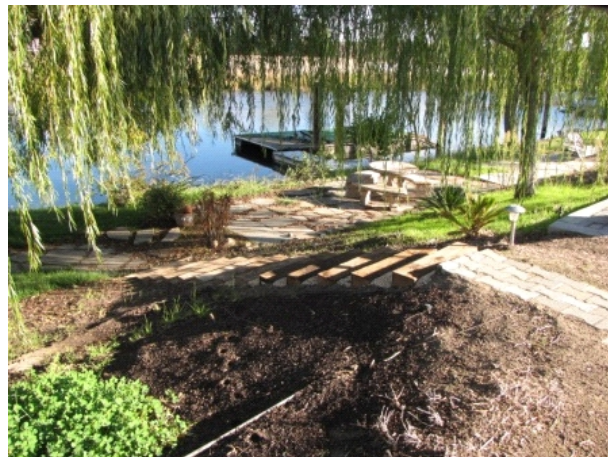
pkazi_s_20110328_067.jpg

Levee Mile Report Line	18
Start Levee Mile	0.83
End Levee Mile	0.83
Location	Land Side
Category	Earthen Levee
Item	Encroachments

View of recently modified steps on the waterward slope of the levee looking upstream.

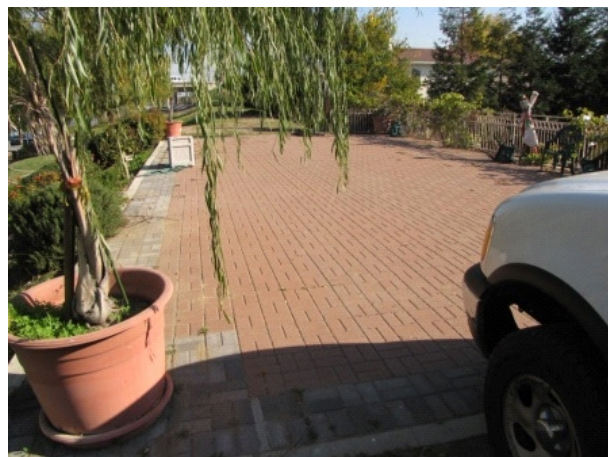
pkazi_s_20110328_123.jpg

Levee Mile Report Line	19
Start Levee Mile	0.83
End Levee Mile	0.84
Location	Crown
Category	Earthen Levee
Item	Encroachments

View of pavers placed on the crown of the levee looking upstream. Potted landscaping and irrigation can also be seen.

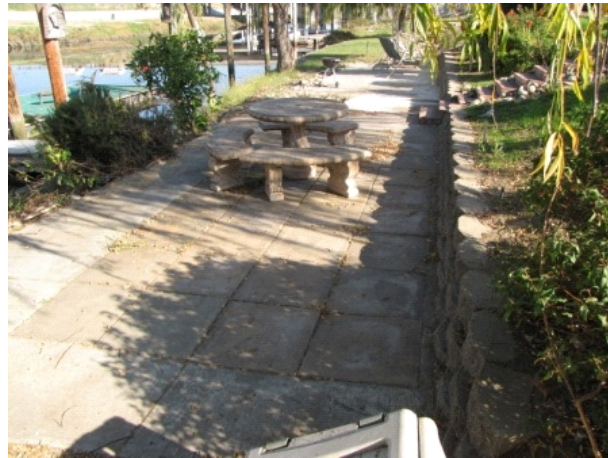
pkazi_s_20110328_127.jpg

View of a retaining wall and patio with furniture in the waterward toe and berm looking upstream.

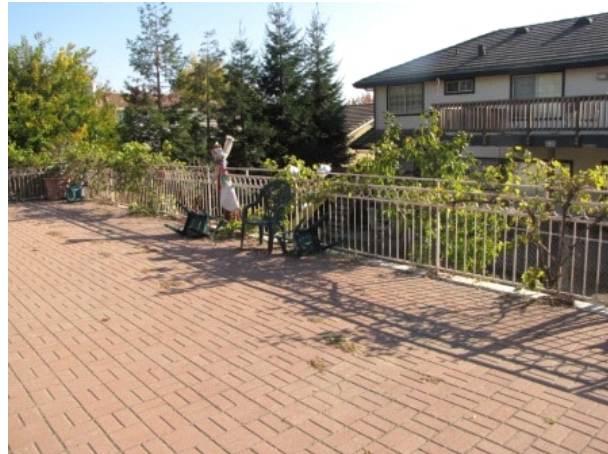
pkazi_s_20110328_124.jpg

Levee Mile Report Line	21
Start Levee Mile	0.83
End Levee Mile	0.84
Location	Land Side
Category	Earthen Levee
Item	Encroachments

View of a fence on top of a large retaining wall in the landward slope looking upstream. Landscaping is growing along the fence.
